Manhole Inspection Summary

Manhole # S03YY1009MH

Insp Date: **8/14/06 12:00 AM**

Location Address: **6008 CLOVER RD** Cross Street: **PARKINGTON AVE**

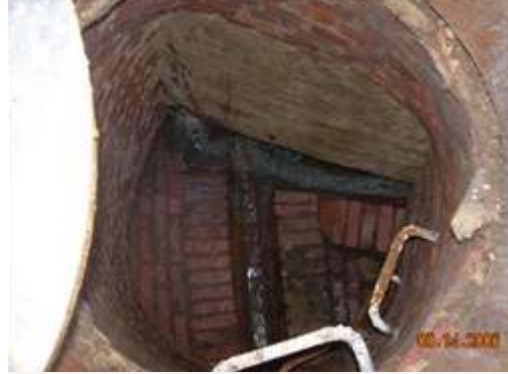
Top View

Bench ☒ Exists Material: **Brick** ☐ Parged ☒ **Debris** (not Condition related)
Condition: ☐ Sound ☐ Cracked ☐ Root Intrusion ☐ Deteriorated ☒ **Leaks** ☐ Debris

Steps Count: **4** Missing: **0** ☐ Corroded

Surcharge ☒ **Evidence Of Surcharge** Depth: **3** (ft.) ☐ Active Surcharge Present

Corroded steps. Evidence of surcharge - Bench debris.

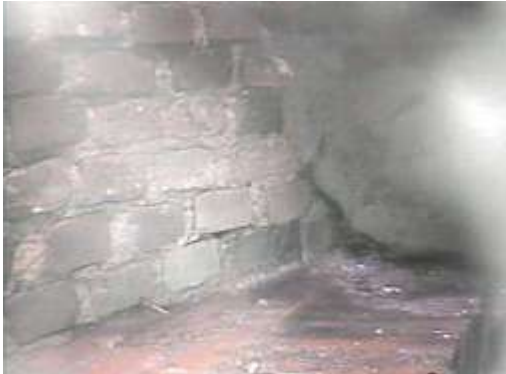
Defect

Comments **Unable to take measurments of O12 pipe due to channel offset overhang. There is Active infiltration in the Barrel.**

Barrel Material: **Brick** ☒ Parged
Shape: **D-Shape** Diameter: **36** (in.) Length: **60** (in.)
Condition: ☐ Sound ☐ Cracked ☐ Root Intrusion ☐ Loose Brick ☒ **Deteriorated**
Infiltration: ☐ None ☐ Joint ☐ Cracks ☒ **Mortar** ☐ Roots ☒ **Wall**

Barrel deterioration and (Active) infiltration.

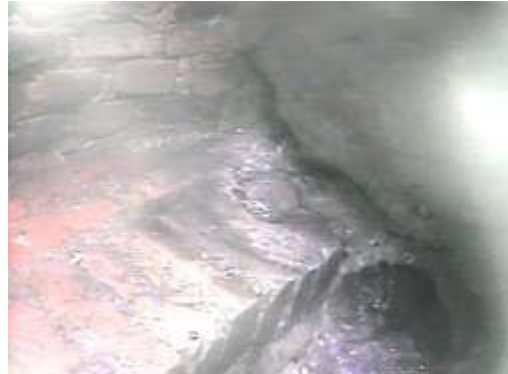
Defect

Barrel deterioration and (Active) infiltration.

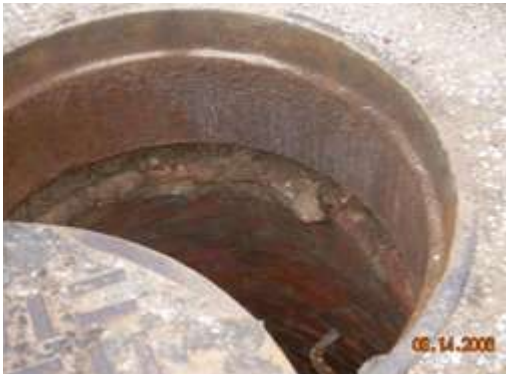
Defect

Frame Offset: **0** (in.) Condition: ☐ Sound ☐ Cracked ☒ **Leaks**

Chimney / Frame Adjustment ☒ Exists Material: **Brick** ☐ Parged Height: **4** (in.)
Condition: ☐ Sound ☐ Cracked ☐ Root Intrusion ☐ Loose Brick ☒ **Deteriorated**
Infiltration: ☐ None ☒ **Joint** ☐ Cracks ☐ Mortar ☐ Roots ☐ Wall

Frame leaks. Adjustment deterioration and infiltration.

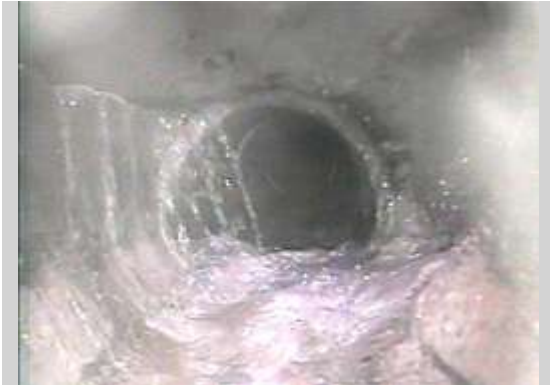
8 in. Circular Gravity Sewer Pipe Out @ 12 O'Clock

Infiltration: **Gusher** Pipe Seal Cond: **Unknown**
